San Carlos Veterinary Hospital (SCVH)
 8618 Lake Murray Blvd.
 San Diego, CA 92119
 (619) 460-3100
 www.sancarlosvet.com

“Katrina”- Cauda Equina Syndrome, Lumbosacral Fusion

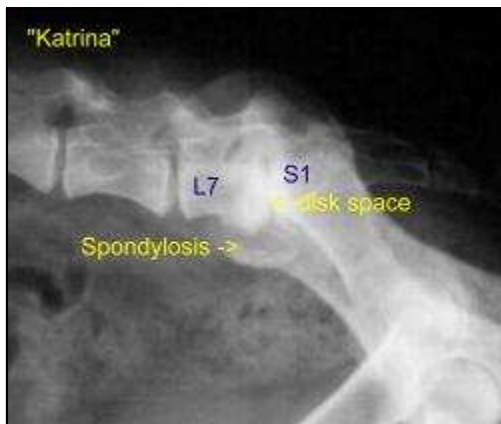
Figure 1. X-radiograph showing spondylosis of the disk space between the L7 - S1 vertebrae.

“Katrina” is an 11½ year old spayed female Husky mix. She was presented with a history of crying, even screaming, when she would get up from laying down, especially in the mornings. Over the previous three weeks she seemed to get better once she was up and had exercised. She began getting worse about nine days before presentation, and started chewing on her right rear paw. Our examination revealed some lower back (thoraco-lumbo-sacral) tenderness. Radiographs of the spine showed marked spondylosis (bony bridging) of the L7 – S1 (lumbo-sacral, or L-S) disk space, with extensive sclerosis (increased density of bone) of the vertebral end-plates, and narrowed disk space. These symptoms indicated a likely disk extrusion (“slipped disk”). Our suspicion was that this was the likely cause of the pain, in certain positions of the lower spine, whereby occasional nerve impingement occurred (Fig. 1).

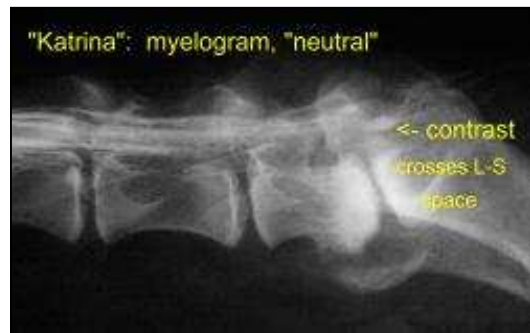
Figures 2 & 3. Myelograms showing minimal loss of contrast when the spinal column was in the neutral (top) and extended (middle) position.

A myelogram was performed to determine if there was spinal canal impingement, and if this occurred in some or all positions of the lower spine. The myelogram (a diagnostic technique whereby contrast is injected into the spinal canal that shows up readily on radiographs) showed loss of contrast across the L-S disk space when the pelvis was maximally extended, but did cross when the pelvis was in neutral or flexed position. This suggested that the pain from nerve impingement occurred in pelvic extension movements (Figs. 2, 3, 4).

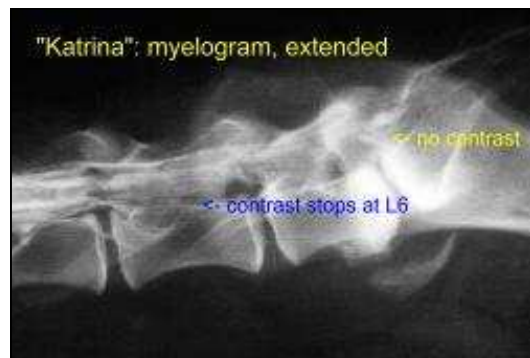
Figure 4. Myelogram showing loss of contrast material when the spinal column was in the flexed position.

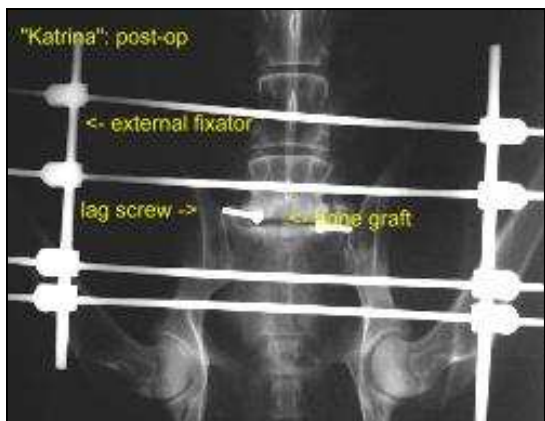
Figure 5. Post-operative ventro-dorsal X-radiograph showing screws and bone graft used to fuse the Lumbo-Sacral spine in a neutral position.

The treatment was to fuse the L-S spine in a neutral position, so it could no longer move into a position to cause nerve impingement. This was accomplished by positioning the spine/pelvis in a neutral position, placing lag screws across the articular facets (bony prominences that make up the joints between the vertebrae), then wedging a cortico-cancellous bone graft, taken from the right iliac wing (of the pelvis) between the dorsal spinous processes of the vertebrae (Figs. 5, 6, 7).

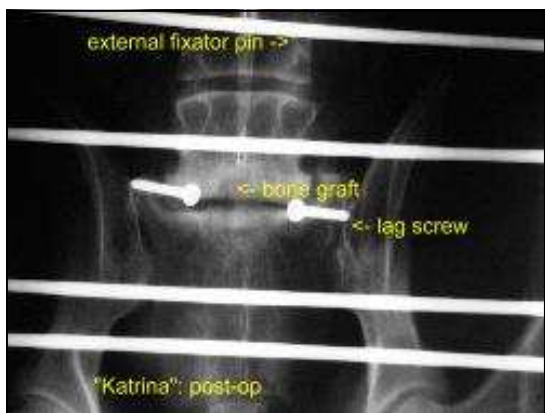
Figures 6. Close-up of the same view shown in Fig. 5.

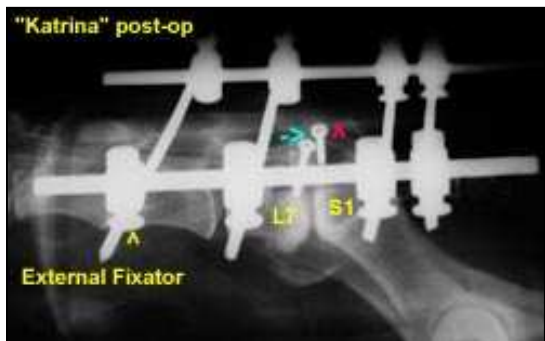
Figure 7. Lateral view of the same area shown in Figs. 5 & 6. Note screws (blue arrow) and bone graft (red arrow).

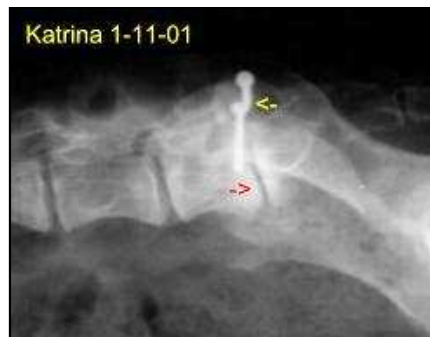
Figure 8. Katrina, Jan. 11, 2001 lateral view showing bone graft (yellow arrow). Note the disk space and that the relationship between the L7 and S1 vertebrae is well maintained (red arrow).

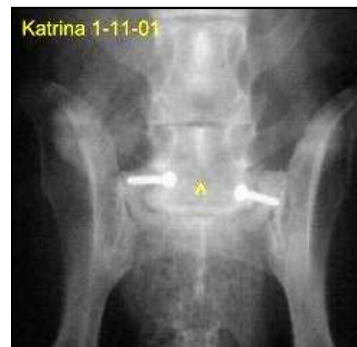
Figure 9. Katrina, Jan. 11, 2001 ventral-dorsal view showing bone graft (yellow arrow)
