San Carlos Veterinary Hospital (SCVH)
8618 Lake Murray Blvd.
San Diego, CA 92119
(619) 460-3100
www.sancarlosvet.com

“Samantha” - Torn Biceps Tendon

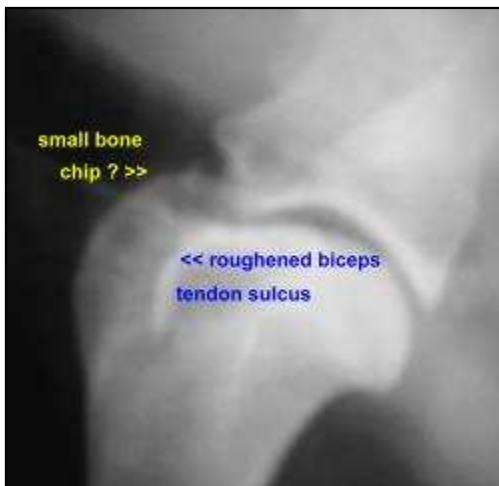
Figure 1. Left shoulder, showing a possible bone chip and a roughened biceps tendon sulcus.

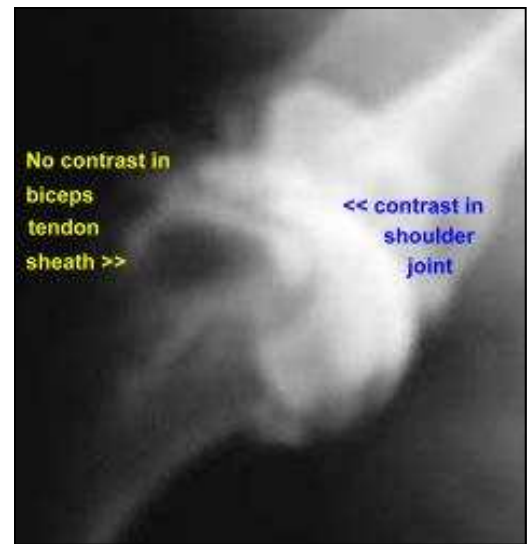
Figure 2. Arthrogram of left shoulder, showing no contrast in bicipital tendon sheath.

One month after her initial presentation, Samantha came in for a re-evaluation. Her lameness seemed less severe, but persistent. She growled at the owner when he bumped her in the left shoulder area. Palpation of the left shoulder elicited definite discomfort. A left shoulder arthrogram was performed (Figures 2 & 4). The arthrogram definitively indicated a problem in the area of the bicipital tendon. Compared to a normal arthrogram (Figures 3 & 5), there was no contrast filling of Samantha’s left bicipital tendon sheath. This suggested that

there was something occluding the flow of contrast into the sheath (likely scar tissue), so surgery was recommended. Additionally, tendon injuries can be diagnosed and evaluated using ultrasound.

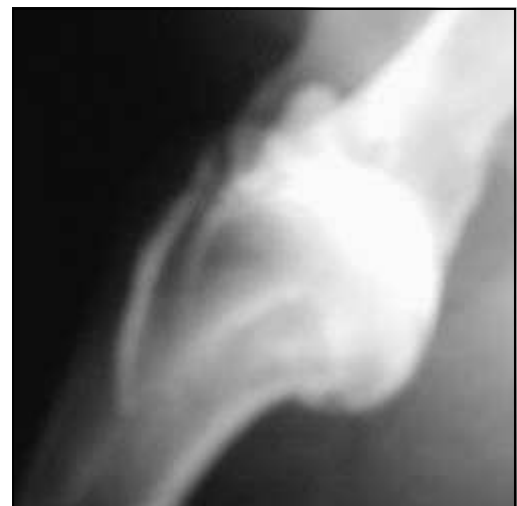
Figure 3. Arthrogram of a normal shoulder (Lateral)

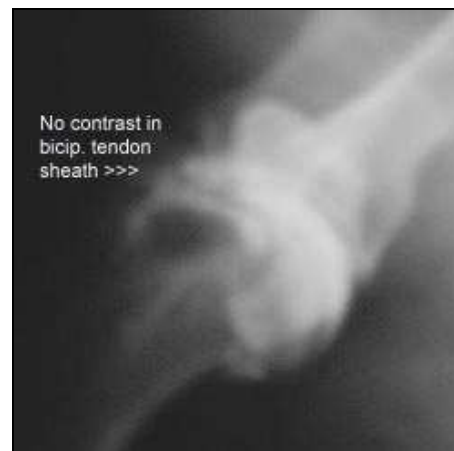
Figure 4. Arthrogram of left shoulder, showing no contrast in bicipital tendon sheath.

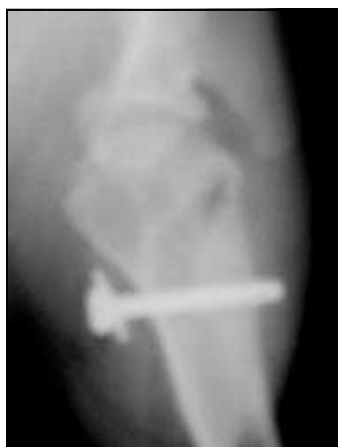
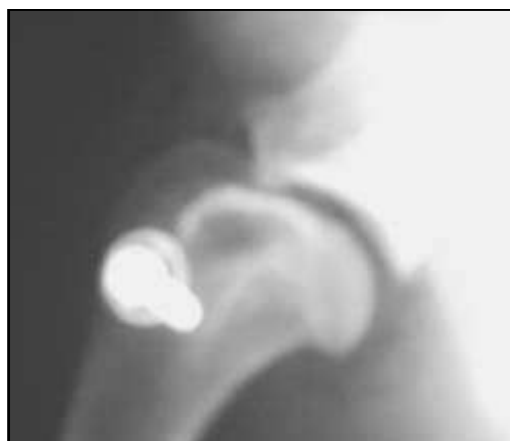
Figures 6 and 7, showing the screw and plastic spiked washer used to crimp the tendon to the bone.

Surgical exploration of the left bicipital tendon revealed a swollen sheath with at least 50% of the tendon torn in the area of the sulcus. The sheath was scarred down and very inflamed. The joint fluid was blood-tinged, pinkish in color. We dissected to an area of normal tendon, drilled a hole in the proximal humerus bone, the anchored the tendon to the bone with a screw and a plastic spiked washer. The spiked washer “crimped” the tendon to the bone (Figures 6 & 7). The damaged segment of tendon was resected and discarded. Her leg was put in a Velpeau (flexion, off-weight-bearing) sling for four weeks (Figures 8 and 9).

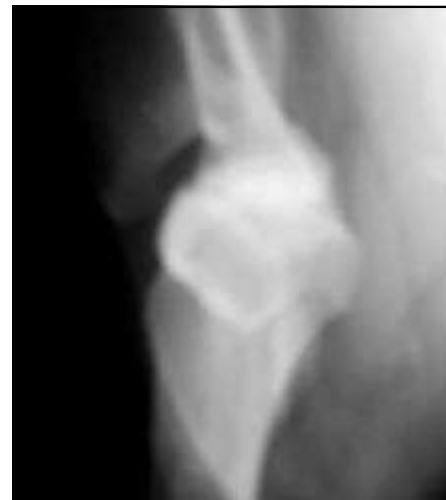
Figures 5. (Anterior-Posterior) arthrograms

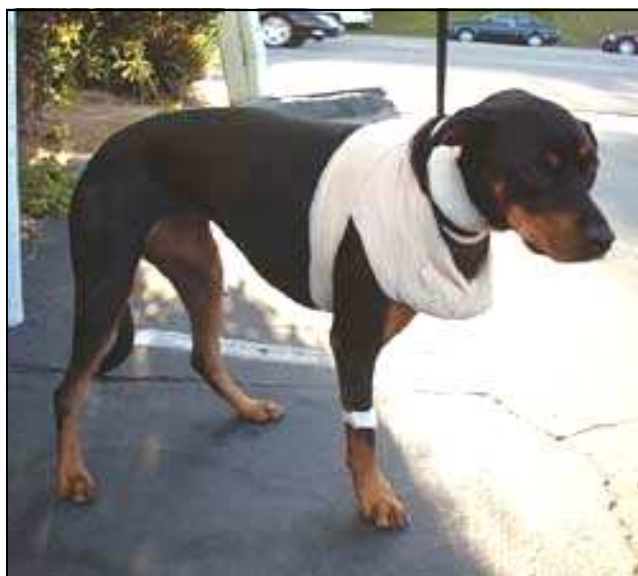
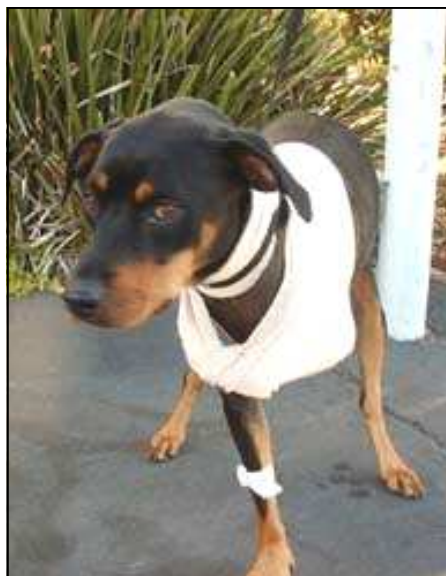
Figure 8 and 9, showing Samantha one day after the surgery with her leg in a Velpeau sling
