San Carlos Veterinary Hospital (SCVH)
 8618 Lake Murray Blvd.
 San Diego, CA 92119
 (619) 460-3100
 www.sancarlosvet.com

“Duracell” - Hit by Car, Plated Femur Fracture

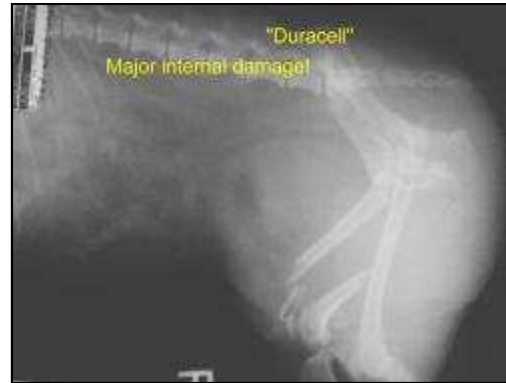
Figure 1. Duracell, Preoperative

Treatment was begun IMMEDIATELY for shock. Radiographs were taken (Figs.1,2) that showed loss of abdominal detail (internal bleeding?) and the broken femur. The packed cell volume, or PCV, a measure of degree of blood loss, was 30%, slightly below normal. We also suspected that there was an extensive traumatic hernia of the lower abdominal wall. Extensive critical care was going to be required initially before any type of surgery could be initiated. Complete evaluation of the extent of the injuries would also be required.

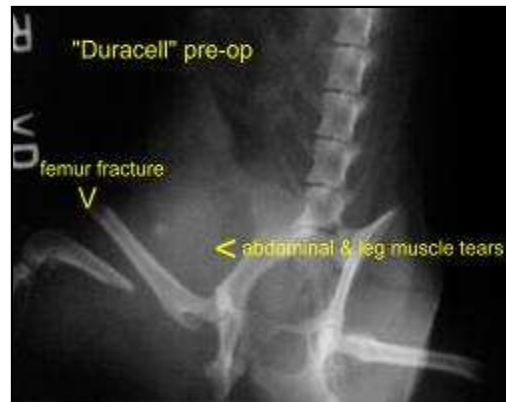
Figure 2. Duracell Preoperative (Ventre-dorsal)

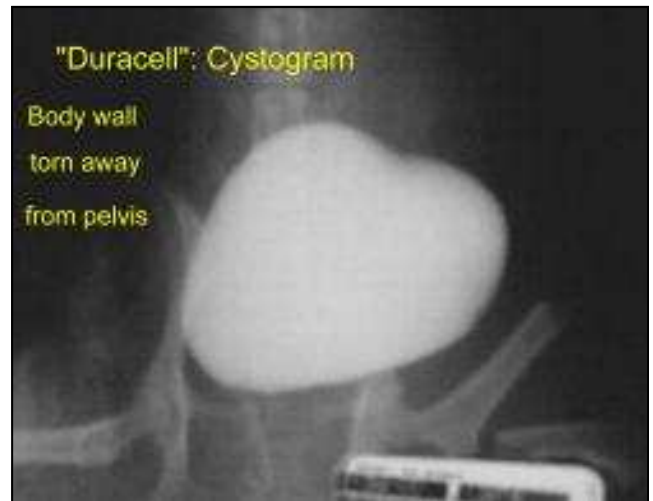
Figure 3. Cystogram #1

Duracell was transferred to the Pet Emergency Center for continued monitoring and treatment. She received an initial blood transfusion that evening because of a continued decrease in her PCV. A positive contrast cystogram (whereby contrast is infused into the urinary bladder so the bladder will show up on a radiograph) was performed. It showed that the bladder was not contained within the abdominal wall, but was actually sitting just under the skin (Figs. 3,4). This confirmed a large hernia! She also developed bloody diarrhea. Two days later, and more stable, Duracell was transferred back to SCVH for surgery.

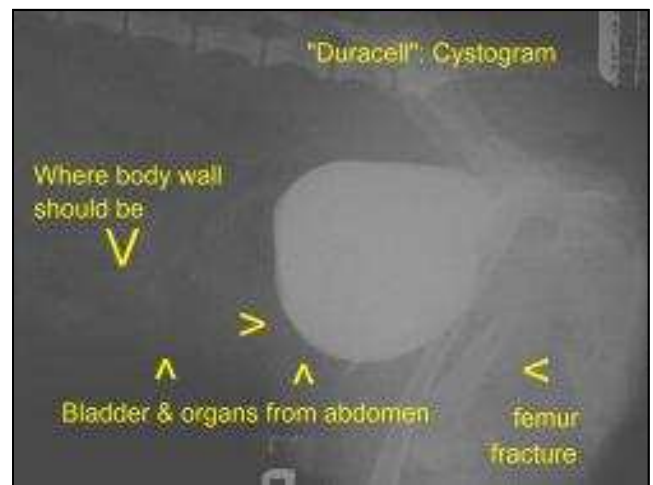
Figure 4. Cystogram #2

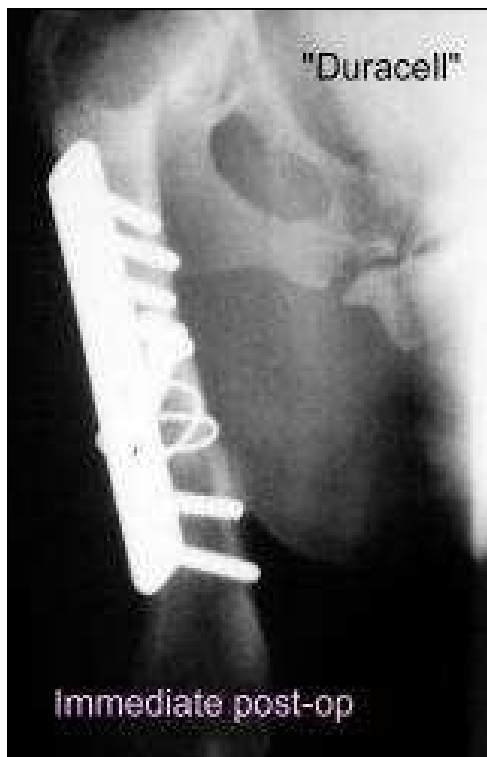
Figure 5. Reconstructed Body Wall

At surgery, the abdominal wall muscles were completely torn away from their attachments to the pelvis. The inguinal muscles helping to hold the right rear leg next to the body were also torn away from their attachments to the pelvis/abdomen. Fortunately the major blood vessels to the right rear leg were still intact. Reconstruction of the abdominal wall was accomplished by placing sutures in the various muscle bellies and attaching those sutures, passed through drill holes in the pubic bones of the pelvis, to the bony pelvis. Then the inguinal ring was reconstructed by re-attaching the muscles of the leg to the muscles of the abdomen. Next the fractured femur was reconstructed utilizing a plate, screws, and wire (Figs. 5,6). A Fentanyl transdermal ("through the skin") pain patch was used for pain management. Duracell was transferred to the Pet Emergency Center for overnight postoperative monitoring.

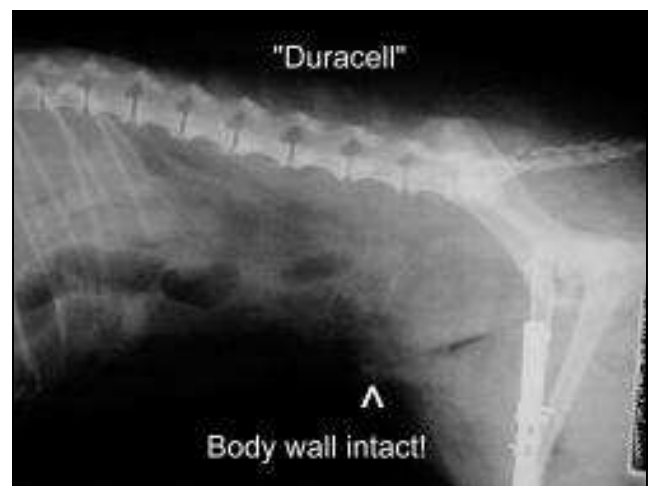
Figure 6. Repaired Femur

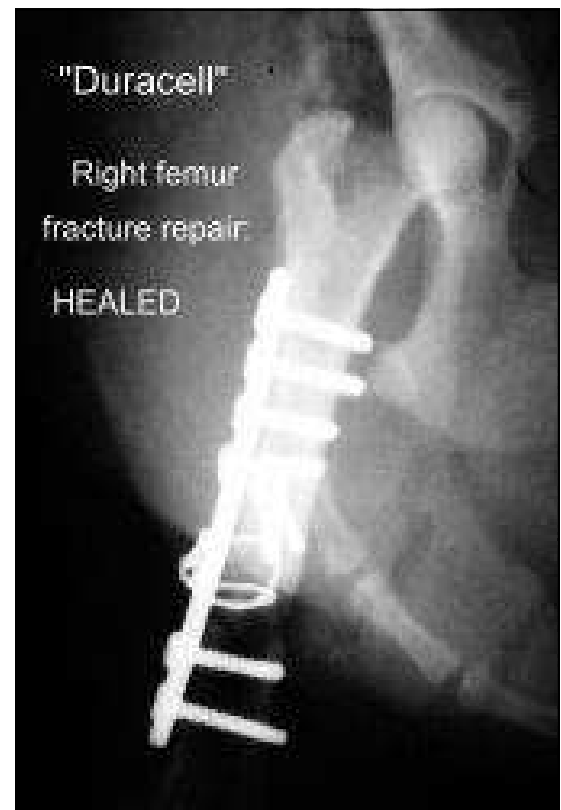
Figure 7. Healed Femur

With a great deal of Tender Loving Care by her mommy, Duracell continued to progress. She began running and playing, her fractured femur essentially healed (Fig.7). Seven weeks after the accident, her blood parameters all returned to normal. She still had some stiffness in the right rear leg due to some muscle limitations, but she returned (psychologically) back to her old lovable self. Physical therapy to increase her right leg range of motion in her hip and knee were recommended.
